## INVESTIGATION OF PROVISIONS OF FIRE SAFETY MEASURES IN BUILDINGS IN DAR ES SALAAM

### ABSTRACT

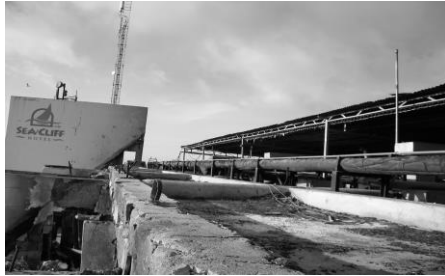
Figure 1 Fire gutted Sea Cliff Hotel in Dar es Salaam

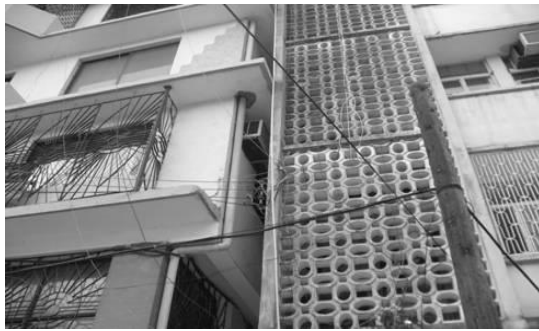
The danger of spread of fire within a building is always accompanied by that of the spread from adjacent buildings. The fundamental protection between buildings is space in sufficient dimensions to prevent spread of fire by radiation or actual flame contact. The investigation established that there are cases whereby the provided space between buildings is not adequate to prevent the spread of fire from one building to the next one as shown in Figure 2 although the building materials for external walls do possess

Figure 2 Two buildings without sufficient distance in between

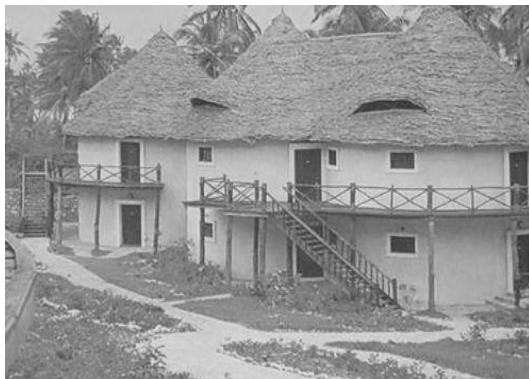
adequate fire resistance. However, there are cases of roofs which have been constructed of grass thatched (see Figure 3) which have a low fire resistance.

Figure 3 Hotel buildings with grass thatched roof

For the case of fire outbreak at Paradise and Oceanic Bay hotels in Bagamoyo, it was established that the hotels buildings were constructed at the common boundary with grass thatched roofs as a result fire from one hotel buildings spread very easily to the next hotel buildings.

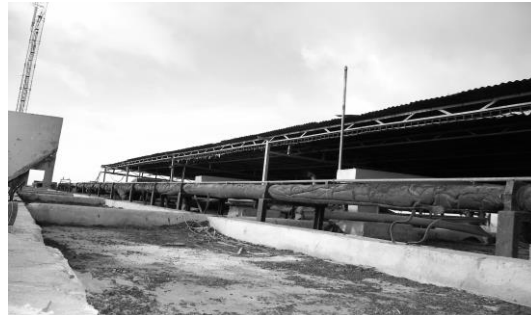
In one of the fire outbreaks incident in Dar es Salaam, it was observed that a duct was a cause of the spread of fire in the building as shown in Figure 4 below as a result fire gutted the whole building. Therefore, flue-like apertures such as ducts, shafts and deep light-wells, should be avoided in the general design of buildings, but where they are necessary as in the case of lift shafts and staircase enclosures, they should be vented at the top to allow smoke and hot

Figure 4 A duct which caused the spread of fire.

gases to disperse to the atmosphere and be constructed using materials with adequate fire resistance.

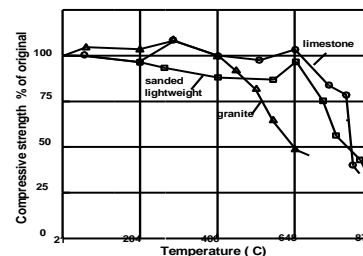
Investigation carried out in Dar es Salaam established that the structural components/elements of most of the public buildings are constructed using reinforced concrete of carbonate (limestone) coarse aggregates that produce concrete which retain most of its compressive strength up to about 650 °C as shown in Figure 5 (Bilow, 2008).

Figure 4 Effect of high temperature on the compressive strength of concrete

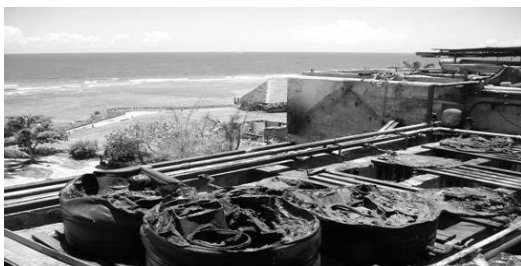
In one of the fire gutted building in Dar es Salaam, a grass thatched roof burnt completely as a result plastic water storage tanks installed on the slab below the roof were exposed to fire and got damaged as shown in Figure 6. Application of building materials which do not have adequate fire resistance was observed for some buildings

Figure 6 Fire gutted plastic water storage tanks

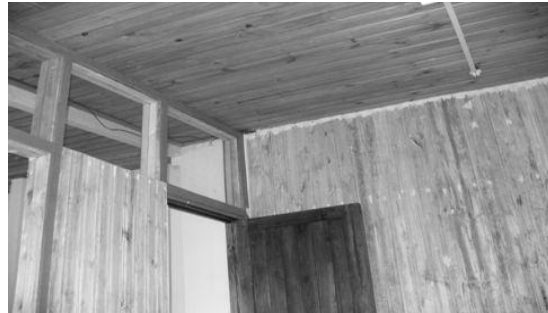
as shown in Figures 3 and 7 where untreated against fire grass and timber are used as roofing and partitioning materials respectively. These materials are likely to contribute to the spread of fire from one building to the next one for grass thatched roofs, and for timber partitions from one room to the next one.

Figure 7 Timber partitions in an office building

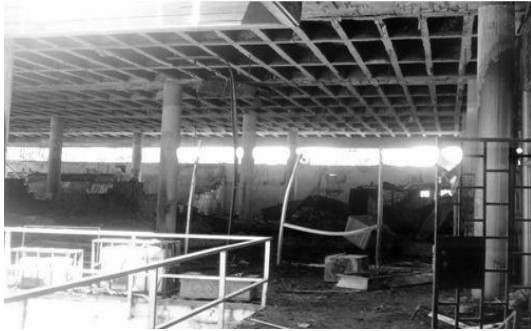
In Dar es Salaam for part of the fire gutted Ushirika building, the office partition walls were erected using timber materials which had a very low fire resistance as a result they were burnt down hence allowing the spread of fire in the building as shown in Figure 8. Unless treated against fire timber products are not recommended as building material for partition walls.

Figure 8 Fire gutted office partition walls at Ushirika building in Dar es Salaam.

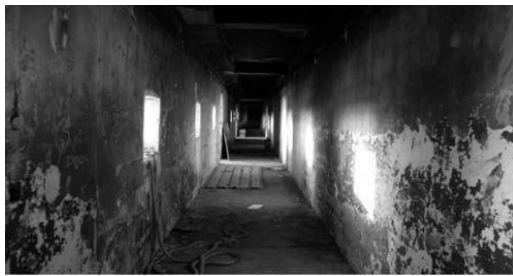
conduits for the spread of fires. It is therefore, important to plan and install fire rated doors or windows or service ducts that will not facilitate the spread of fires. Doors and windows should be made of materials with sufficient high fire resistance and should have door closers or other mechanisms that cause them to close in the event of a fire. Recently in Dar es Salaam, the presence of windows without adequate fire resistance caused the spread of fire to another corridor as shown in Figure 9.

Figure 9 Windows without adequate fire resistance in a wall.

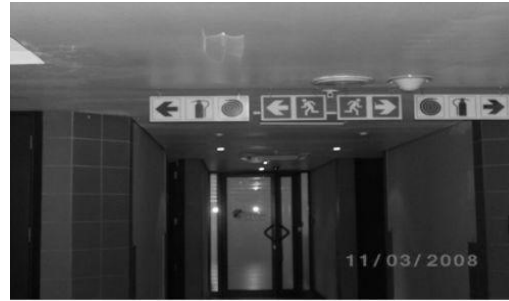
During an investigation carried in buildings in Dar es Salaam to assess provisions for fire safety measures, it was observed that in some buildings fire rated doors are provided as shown in Figure 10. It was also established that in some buildings, stairs in fire escape routes are made

Figure 10 Fire proof doors.

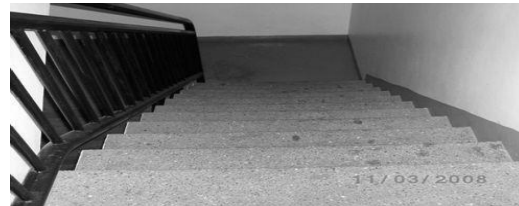
of materials with a high friction coefficient to minimize sliding (see Figure 11) as compared to materials for stairs within the normally used routes which have a small coefficient of friction

Figure 11 Stairs along the fire escape route as it is shown in Figure 12.

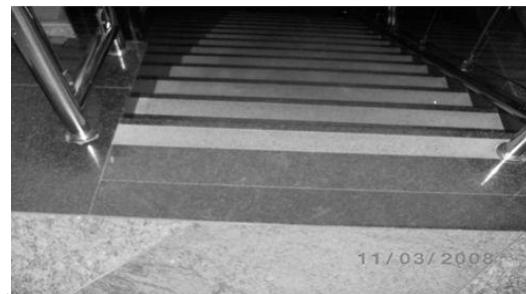
Figure 12 Stairs along the normal routes

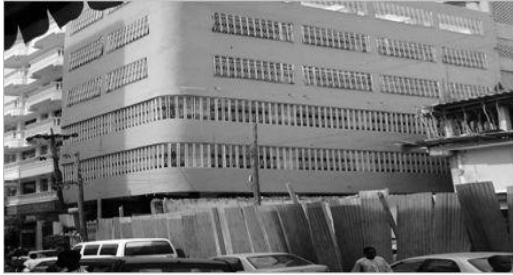
Buildings have to be designed and constructed to allow occupants to escape in case of fire. During the investigation, a building shown in Figure 13 was found to have metal grills provided on all openings as a result in case of fire outbreak, rescue measures and efforts may be hindered.

Figure 13 A building with metal grills on openings
